## Structural Observations on Macedonian Tower, Edirne

U. Almac

M. Alaboz & I.E. Bal

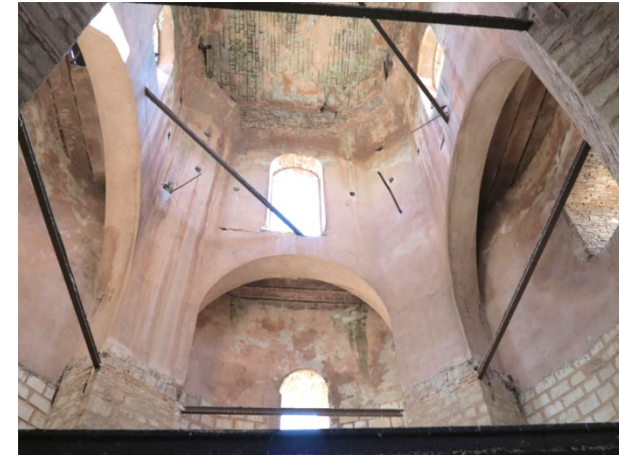
Reinforced concrete roof of the tower (2014)

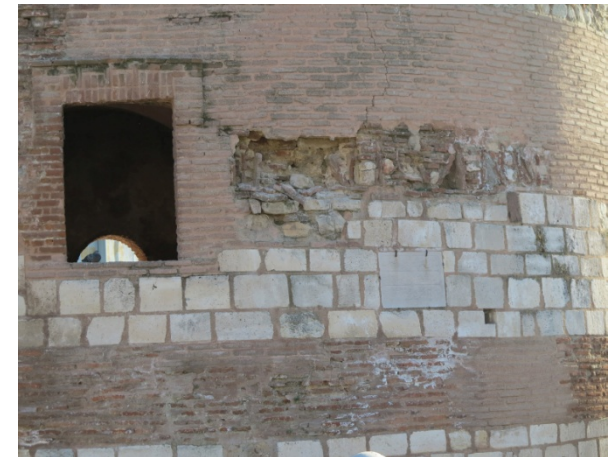
Random fills and irregular patterns of the walls, 2014

- brick bands -- consistency ?
- random fills and irregular patterns (earlier repairs and alterations)

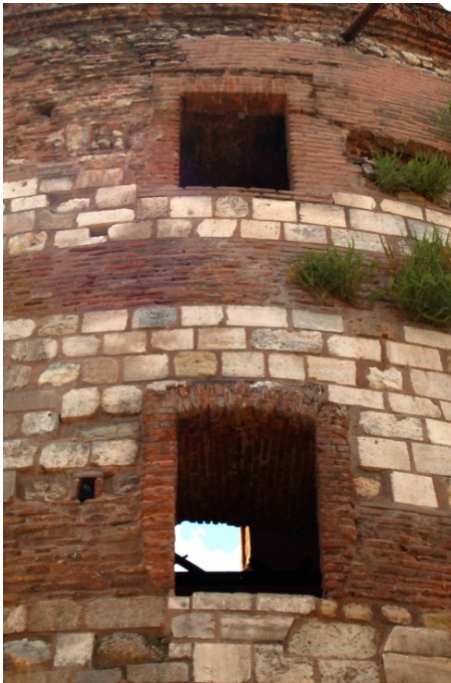
Decay and vegetation on masonry walls

- surface loss
- degradation of binding material
- corrosion of later structural steel members
- vegetation on surfaces

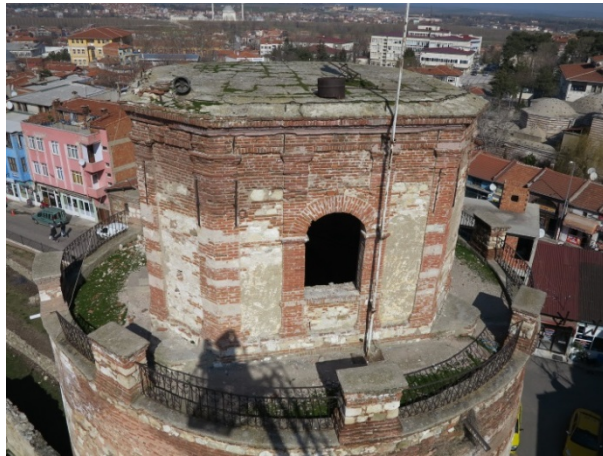
The roof of the tower

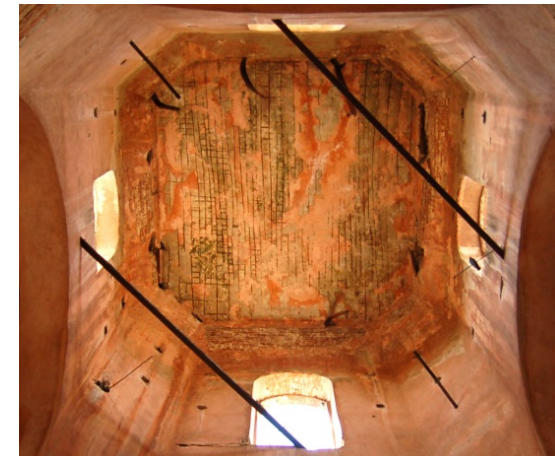
Damages on the upper part of the structure
