## Structural Observations on Macedonian Tower, Edirne

U. Almac

M. Alaboz & I.E. Bal

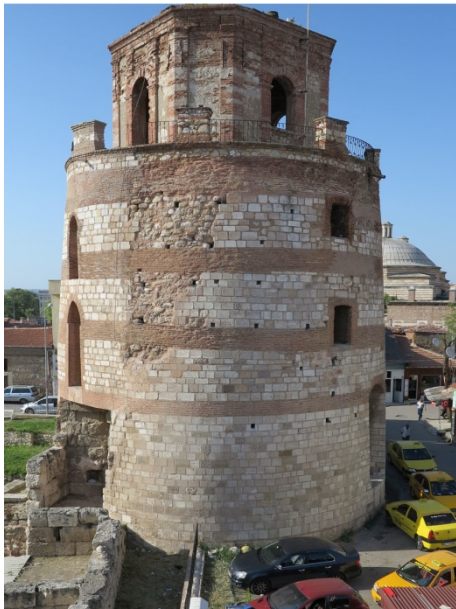
Macedonian Tower, Edirne, 2014.

- brick bands -- consistency ?
- random fills and irregular patterns (earlier repairs and alterations)

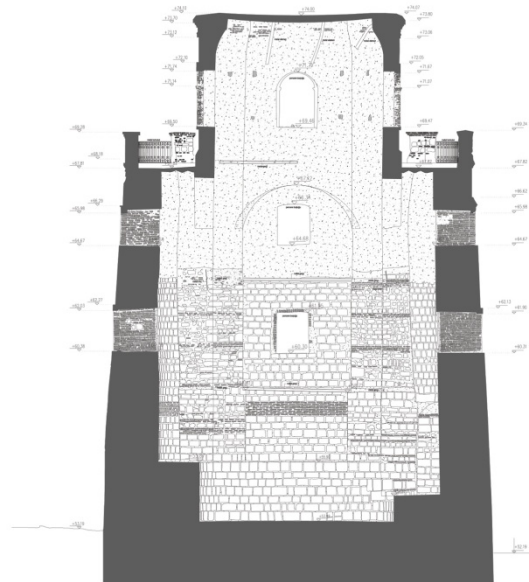
Scaled drawings from the Macedonian Tower, Edirne (Muka Architects, 2015)

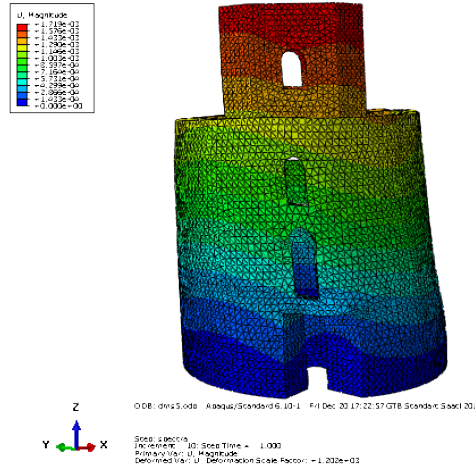
Displacements of the structure under lateral loading, 2015

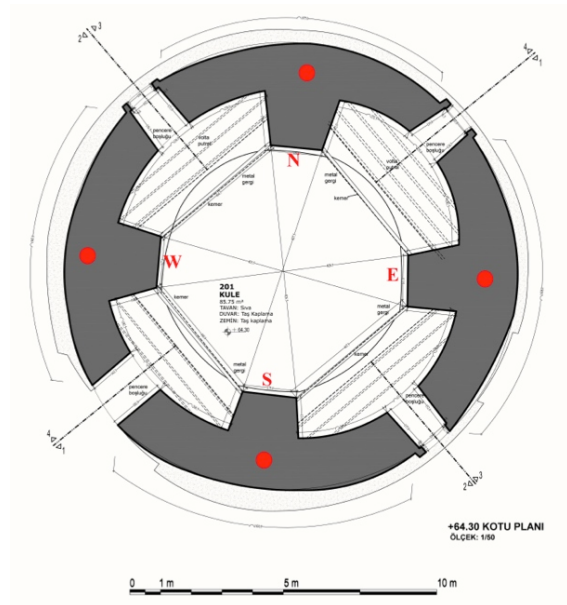
The location of sensors at the roof, 2016

- The structure is assumed to be excited by wind and traffic.
- The sensors were placed on 2 different levels. Four sensors were placed on upper level and two at the bottom level.
- The recording duration was approximately 20 min with 100 Hz sampling frequency.
- Digitized data was recorded with a notebook computer, and then analyzed on another computer at a later time ( the Frequency Domain Decomposition method, implemented with the ARTeMIS extractor software)

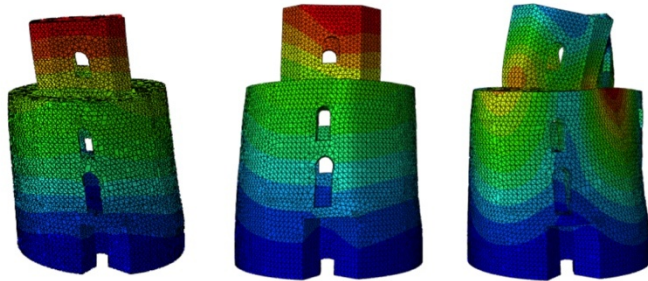
Three mode shapes according to the Eigenvalue analysis

- Initial material properties of the model was modified in order to match test results

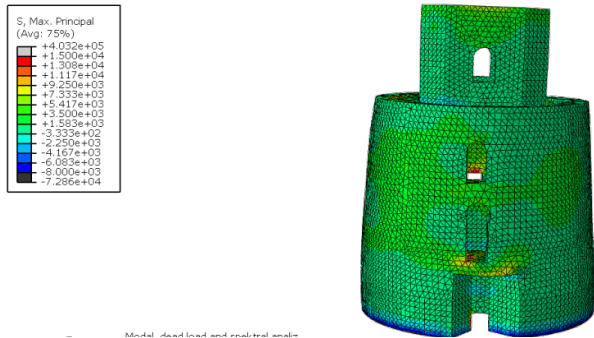
Stress distribution of the structure under its own weight
